Manhole Inspection Summary

Manhole # S13A__015MH

Insp Date: **12/3/07 4:08 PM**

Location Address: **REAR OF 2801 W LANVALE ST** Cross Street: **DUKELAND ST**

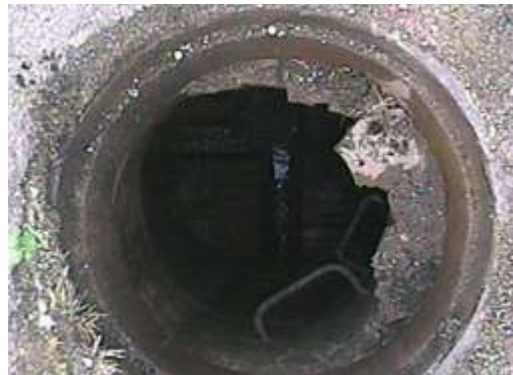
Defect 1

Condition: ☐ Sound ☐ Cracked ☐ Root Intrusion ☒ **Loose Brick** ☐ Deteriorated

LOOSE BRICKS ON FRAME
ADJUSTMENT

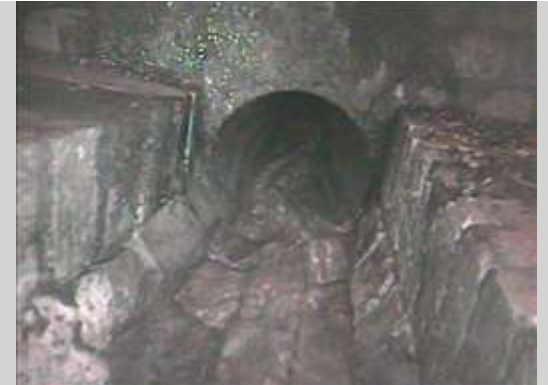
12 O'Clock Outflow

Pipe Height: (in.) Direct
Pipe Material: **Clay** ☐ Pipe Lined
Invert Depth: **7.71** (ft.) Flow Characteristics: **Fast**
Deposits: ☒ None ☐ Mud ☐ Sludge ☐ Debris ☐ Grease
Silt Depth: (in.) Deposits Extent:
Infiltration: **None** Pipe Seal Cond: **Sound**

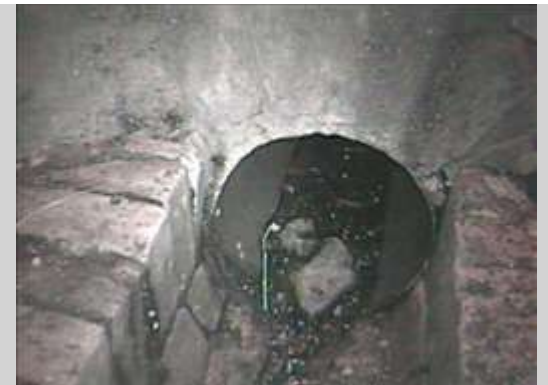
6 O'Clock Inflow

Pipe Height: (in.) Direct
Pipe Material: **Clay** ☐ Pipe Lined
Invert Depth: **7.44** (ft.) Flow Characteristics: **Slow**
Deposits: ☐ None ☐ Mud ☐ Sludge ☒ **Debris** ☐ Grease
Silt Depth: **0.5** (in.) Deposits Extent: **Light**
Infiltration: **None** Pipe Seal Cond: **Sound**
